**FACTUAL REPORT OF GEOTECHNICAL  
INVESTIGATIONS**

**Port Otago – Project Next Generation**

Date: August 2008  
Reference: 6-CGP00.01 / 005DD  
Status: Final  
Report #: 1230

The following report outlines the factual data related to the geotechnical investigation completed for the dredging portion of Port Otago Ltd's "Next Generation" infrastructure development. Geotechnical investigation included subsurface investigation and laboratory testing. The two main objectives of the proposed geotechnical site investigation and laboratory testing were to (1) achieve a detailed description and characterisation of the materials to be dredged, (2) determine whether or not the sediment will be contaminated.

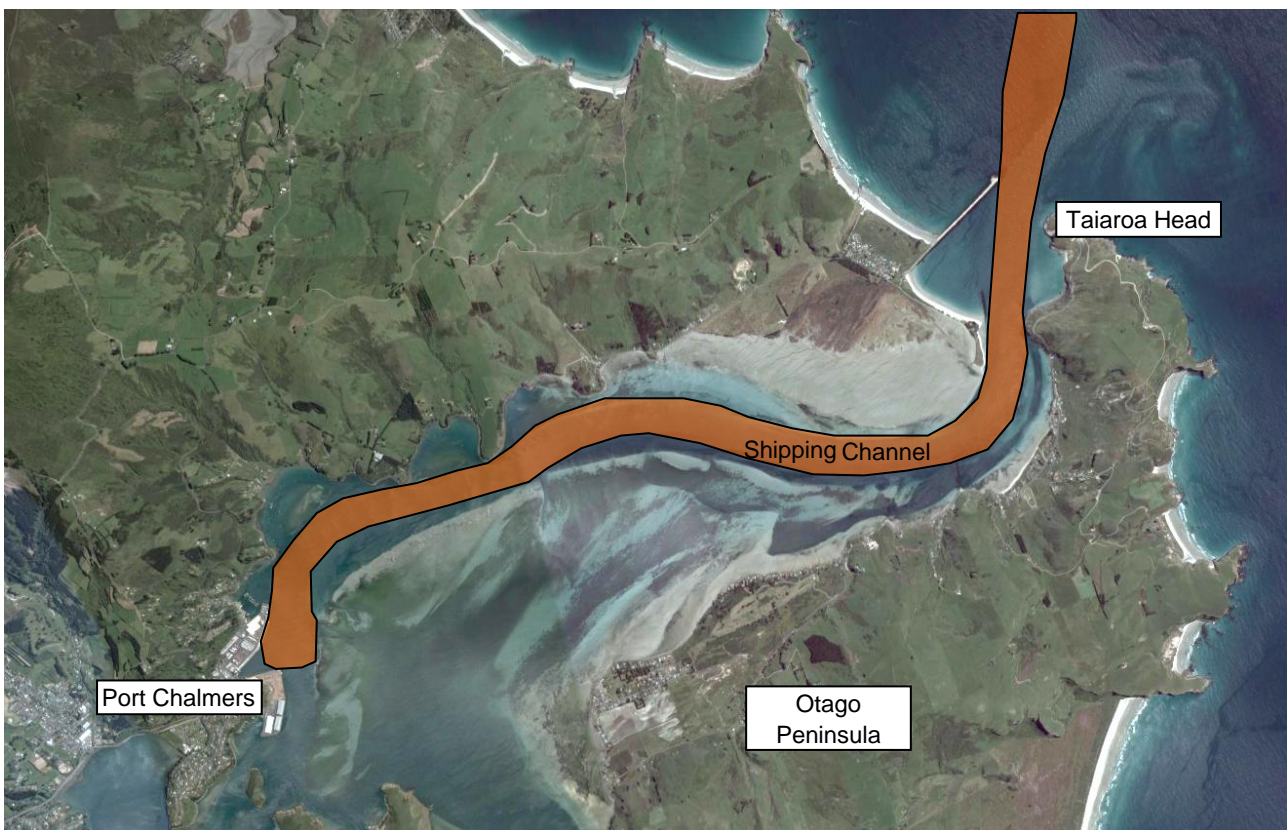
**Figure 1 – Aerial photograph of the shipping channel.**

The following report outlines the factual data related to the geotechnical investigation completed for the dredging portion of Port Otago Ltd's "Next Generation" infrastructure development. The purpose of this development is to enable larger container vessels to be serviced at Port Chalmers. The project includes the provision of new plant and container handling equipment as well as the widening and deepening of the shipping channel. The channel is to be deepened along various sections from Port Chalmers past Taiaroa Head as shown in Figure 1 below as well as in Appendix A.

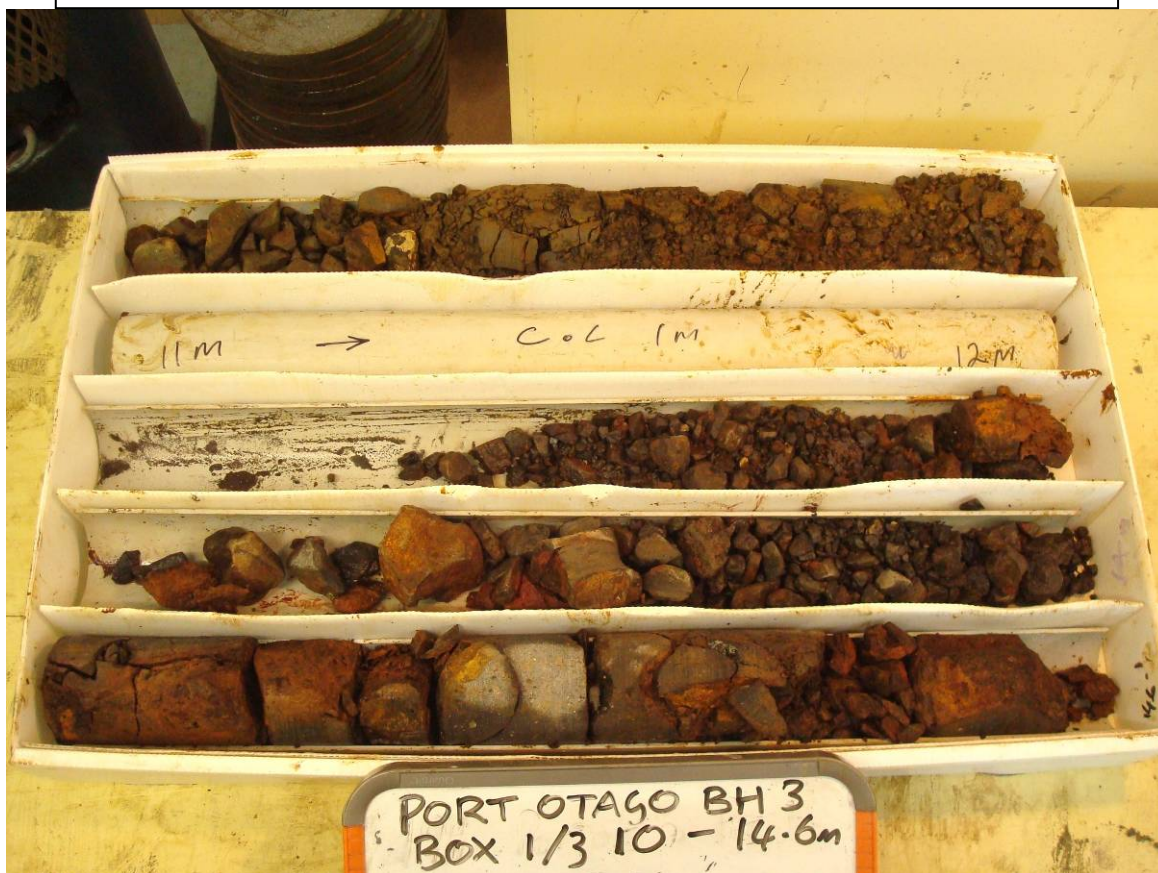
**B3 – Basalt Cobbles and Highly Weathered Basalt**

This was the least common unit and was only encountered at Rocky Point and Acheron Head. This unit consisted of completely weathered basalt near surface and moderately weathered basalt at depth. Borehole B5 encountered basalt cobbles off Pulling Point but the borehole was terminated due to bad weather. It is likely that this unit is also present at Pulling Point. Rock strength ranged from extremely weak to weak within the upper 2 to 4m and became moderately strong to very strong below this. The spacing of defect or discontinuities ranged from closely spaced to very closely spaced. Laboratory testing returned uniaxial rock strength values of 101 MPa and 62 MPa for B3 and B4, respectively.

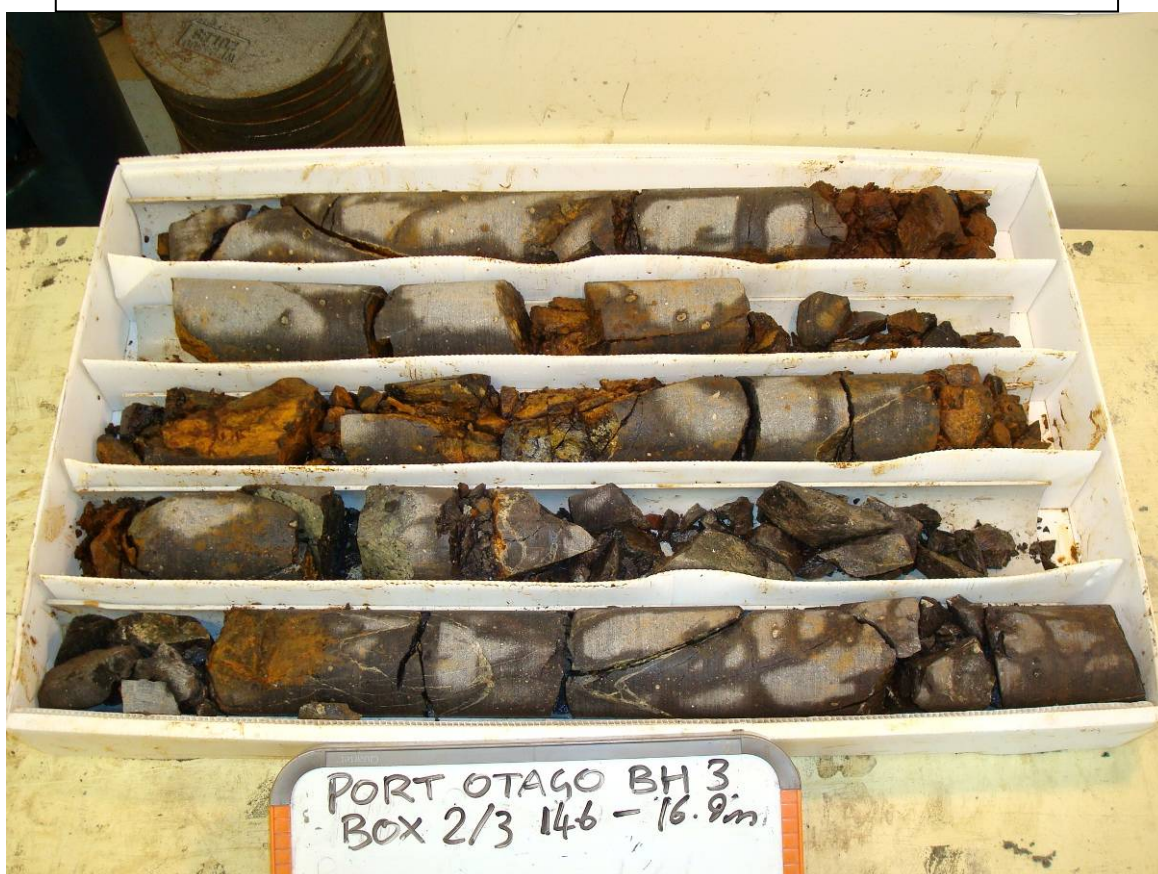
**B3 – Moderately Weathered Basalt**

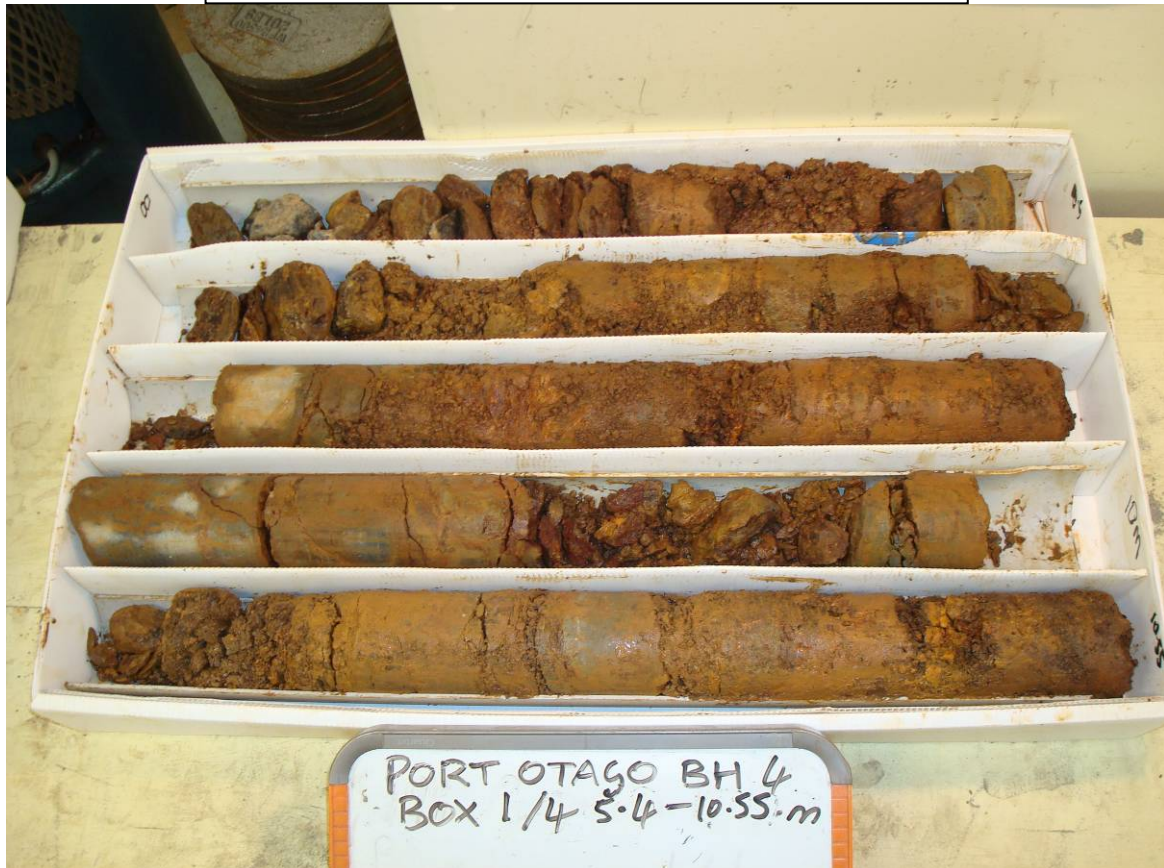
**B4 – Completely Weathered Basalt**

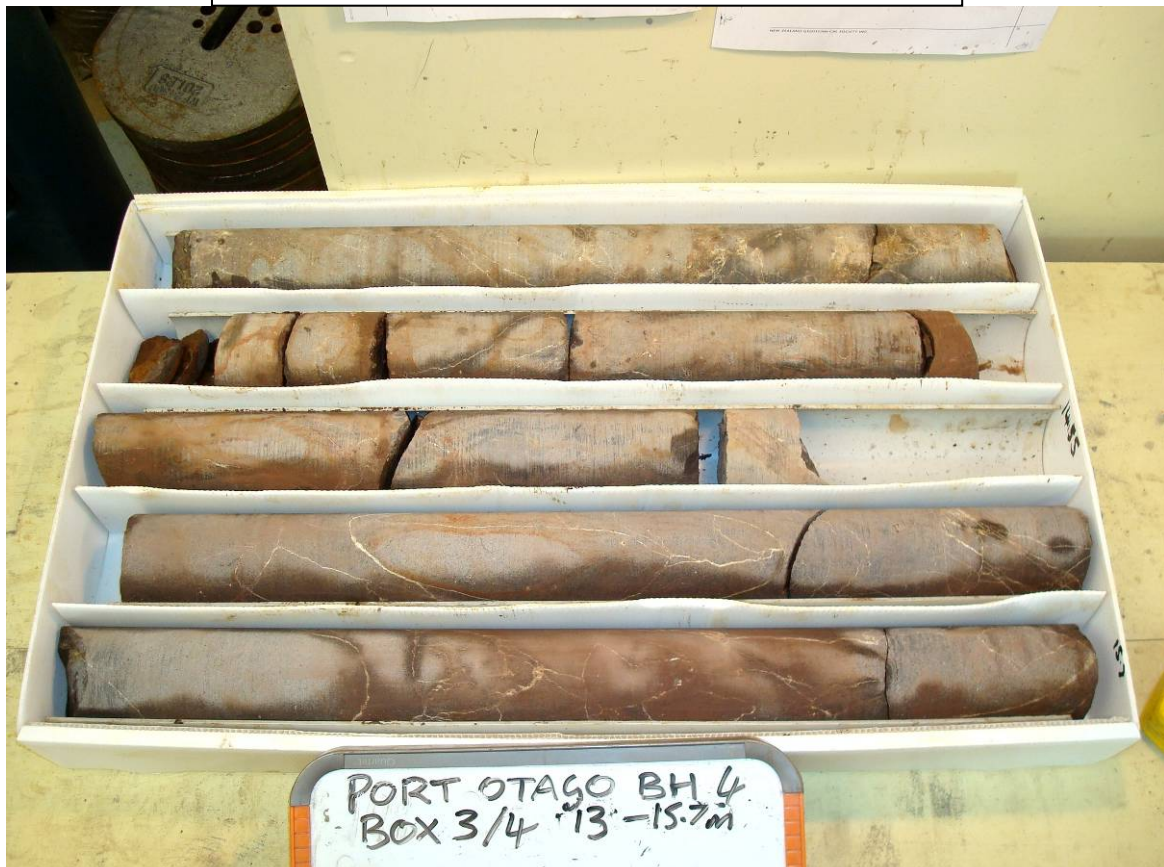
**B4 – Moderately Weathered Basalt**
