LONG MAC GROYNE, OTAGO HARBOUR

The History of Development and its function Past, Present and Future

Prepared for
Port Otago Limited
August 2014

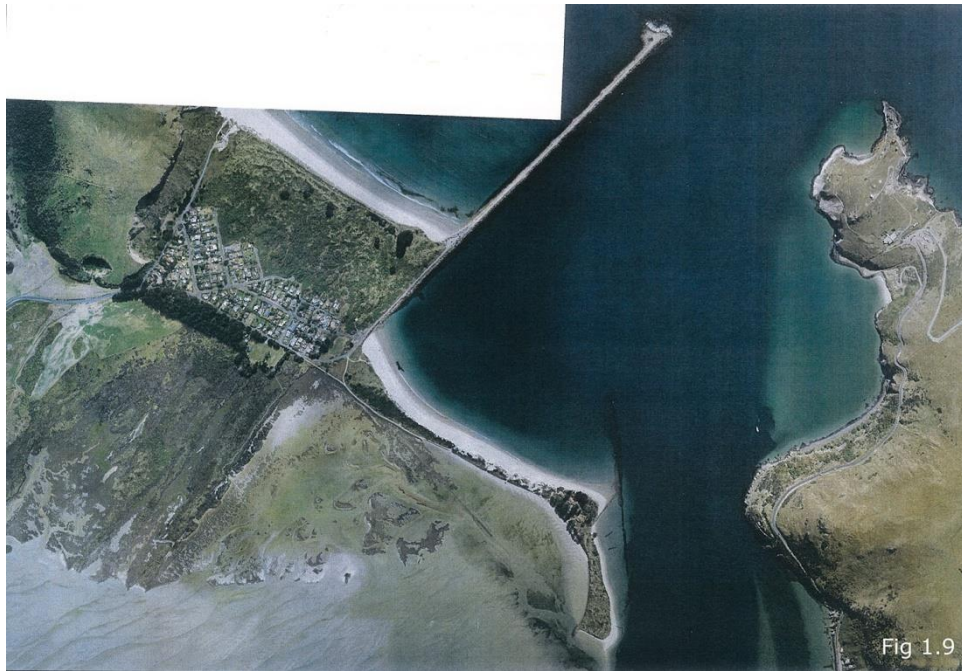
Figure 1.9 – Aerial photograph showing the Long Mac, together with several of the remnant secondary groynes

The most northerly structure remains evident today, refer Figure 1.9, and appears to have been constructed to a similar height as the Long Mac. The figure clearly shows the build-up of sediment that has occurred on the upstream, or Shelly Beach side of this secondary groyne. Several, largely sand covered rubble mounds are also evident further along "The Spit" toward the jetty.

Figure 1.9 Photograph showing the Long Mac, together with several of the remnant secondary groynes. (*Source Google Earth*)
